Landslide prevention project

Municipality of Chelsea

Information session

February 26, 2018

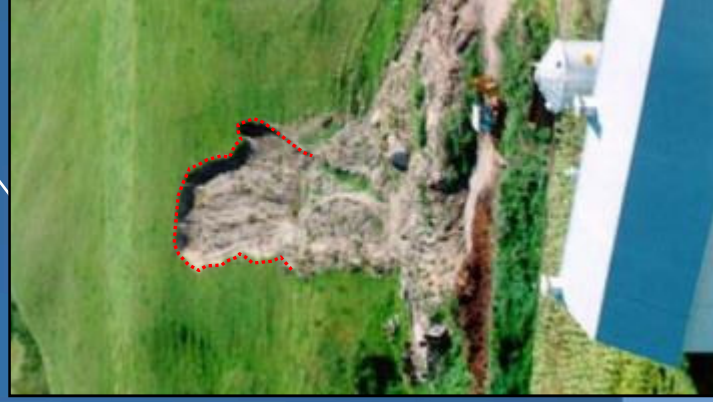
Retrogression $\leq 2H$ or 40 m

Surficial

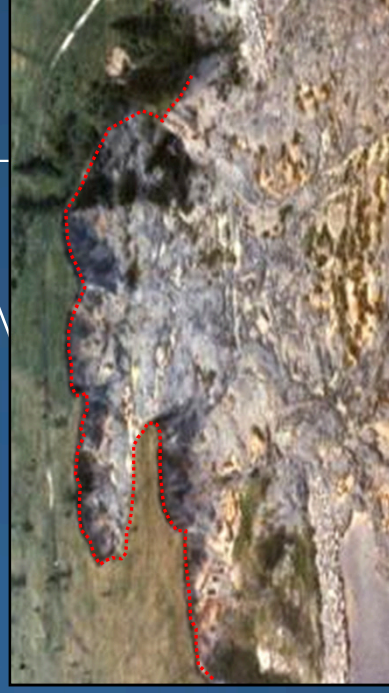
Retrogression $> 2H$ or 40 m

Flowslide

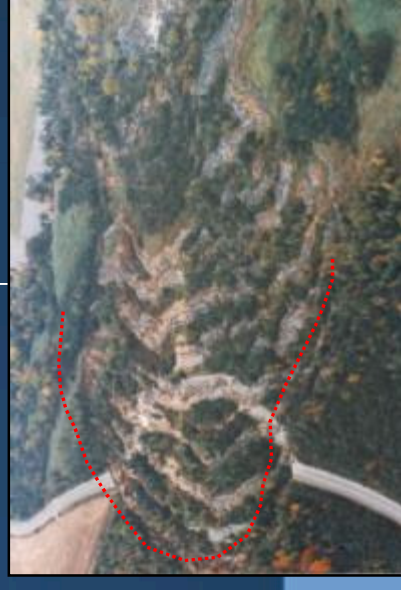
Spread

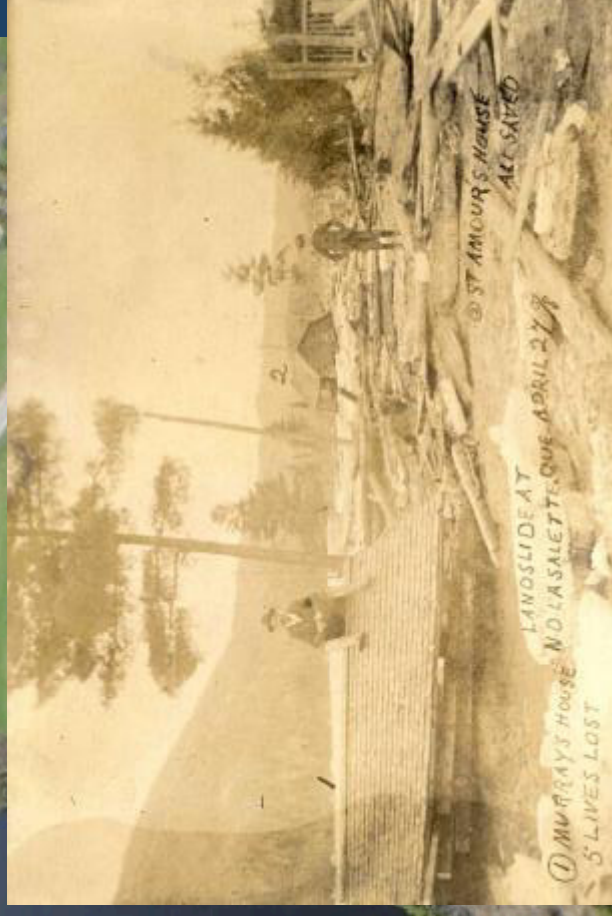
Notre-Dame-de-la-Salette, june 2010

Landslide occurred in an agricultural field and reached 425 m from the top of the slope.

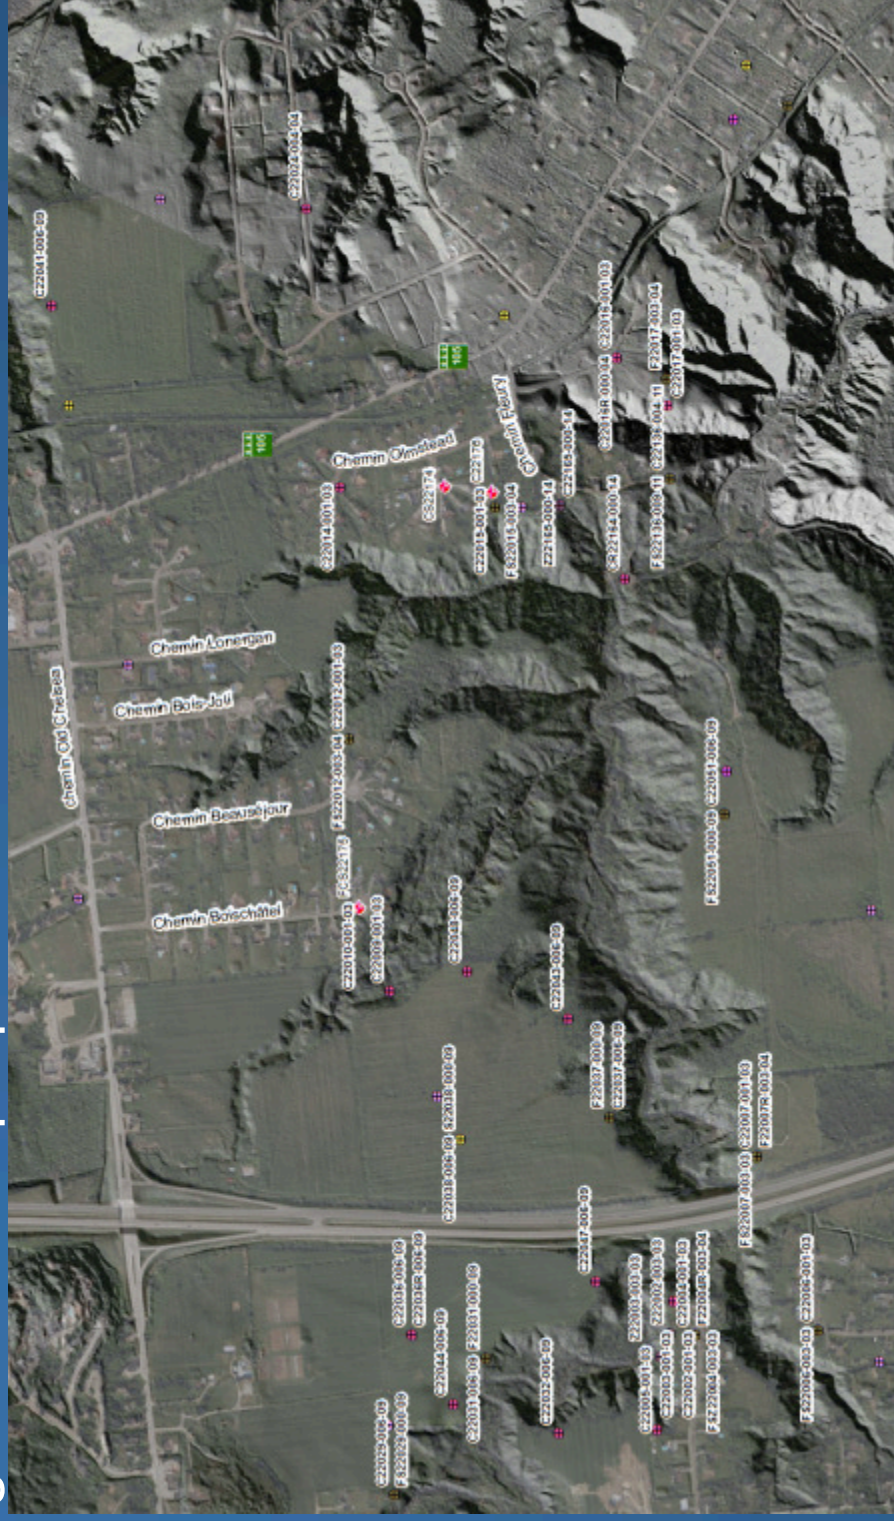
- Investigations allowed to determine local stratigraphy and geotechnical properties.

Field inspections were carried out from 2003 to 2015

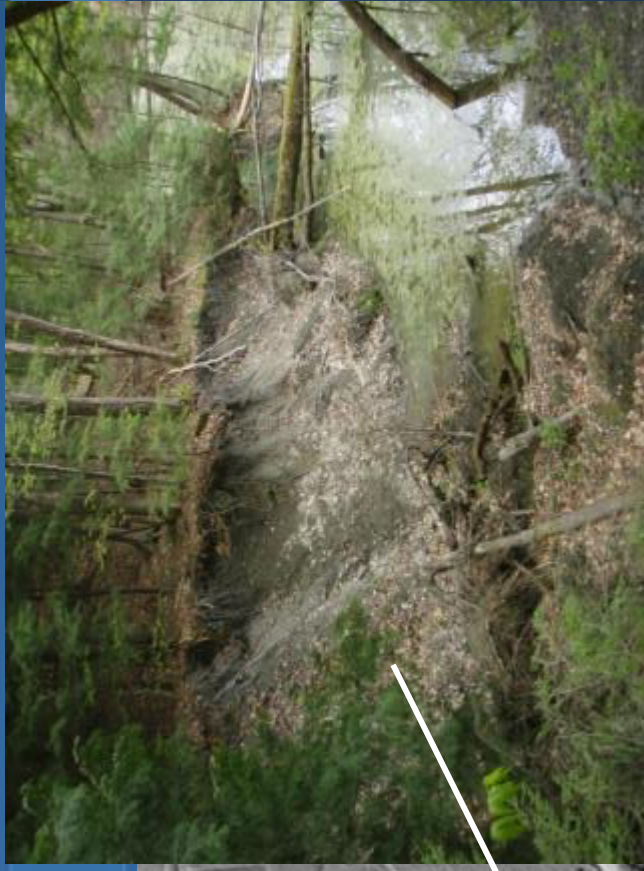
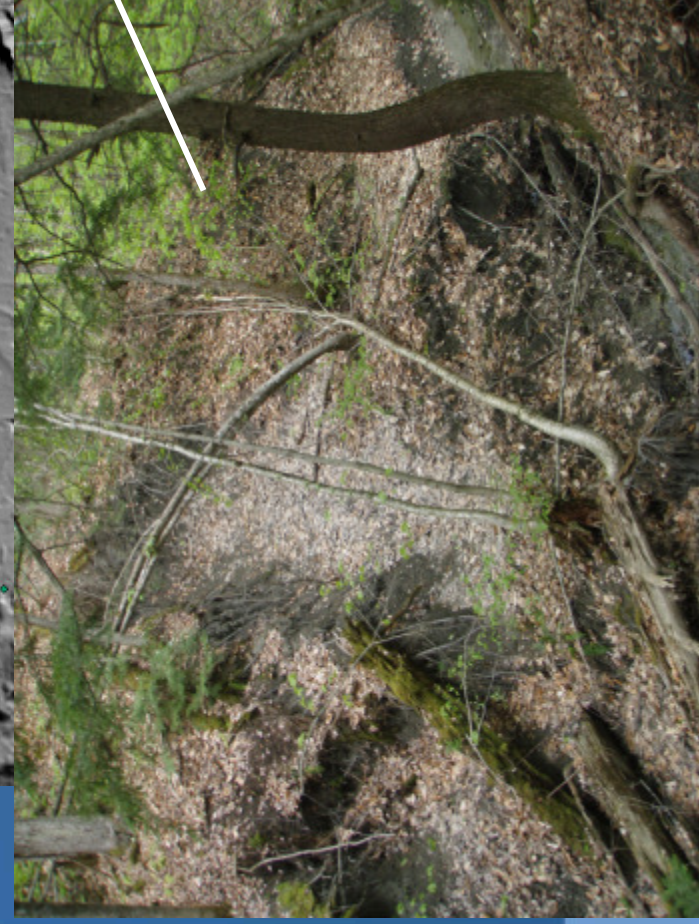
The creek is very active and evidence of severe erosion has been noted.

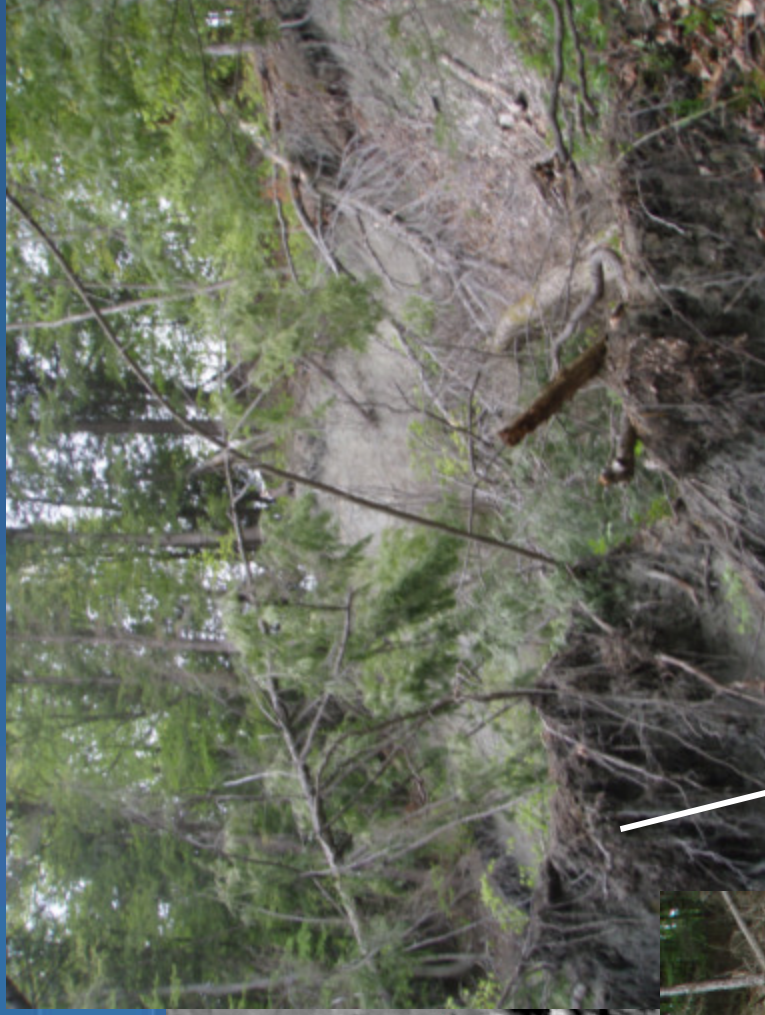
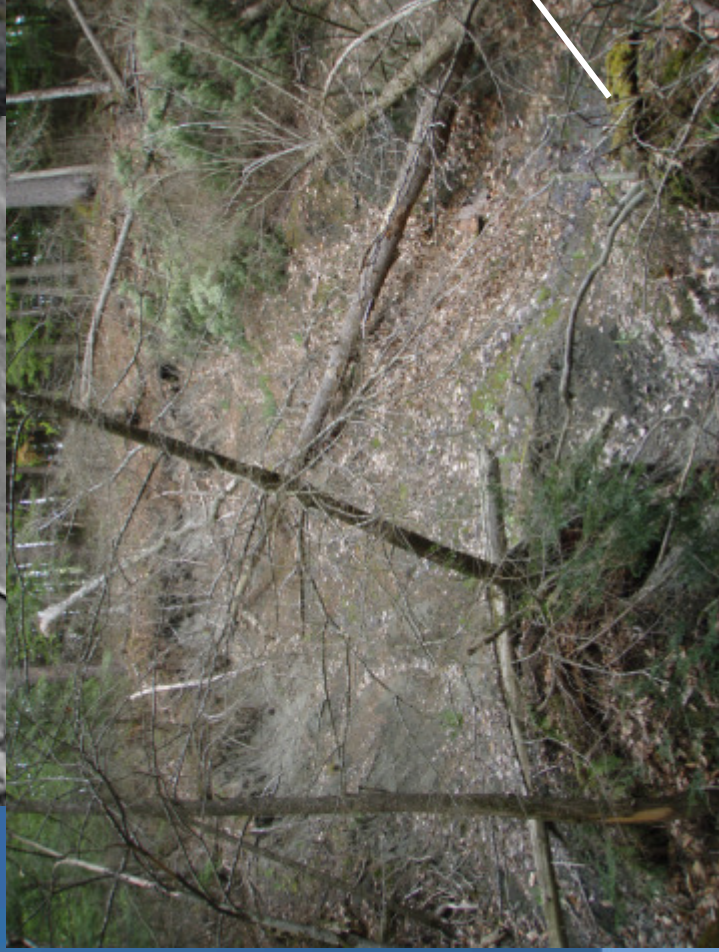
Small-scale landslides are also present along the watercourse.

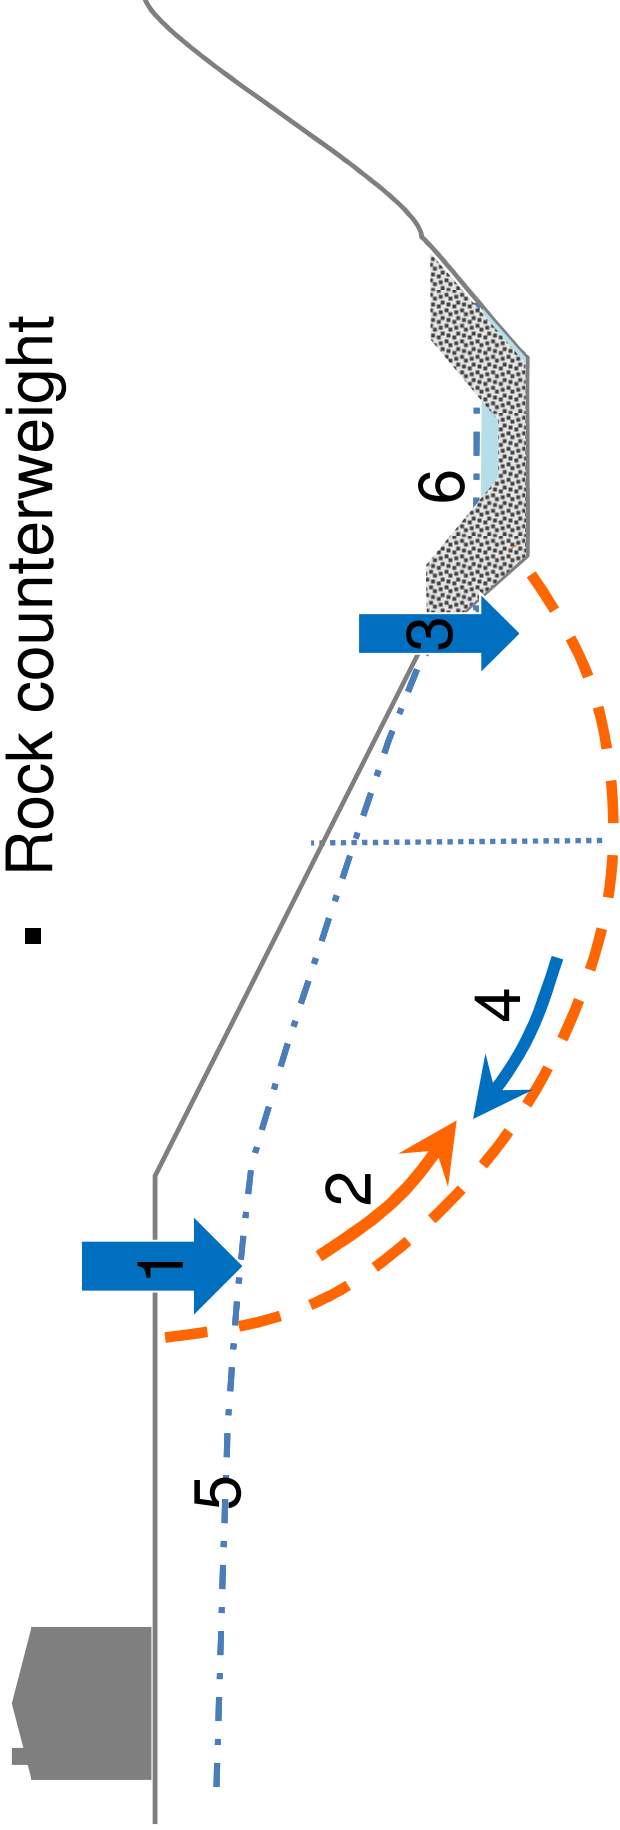
Very simply put, a landslide is the movement of a slope downward under the influence of gravity (1). In clayey soils, landslides often occur along a circular-shaped failure surface.

In order for the landslide to occur (2), the force in (1) must overcome several counteracting forces. The weight of the base of the slope, also under the influence of gravity (3), and the intrinsic strength of the material (cohesion and friction, 4) also act as counteracting forces. The slope is stable for as long as there is balance of the opposing forces. The balance can be disrupted when material is removed from the bottom of the slope, whether it is due to the erosion of the watercourse (natural causes) or to an excavation (human-related). Seasonal variations of the underground water table can also trigger a landslide. When the water table rises, the strength of the soil decreases, which affects the balance of forces.

A rock counterweight (6) acts as an additional weight to the natural counteracting force of the base of the slope (3) and helps stabilize a slope.

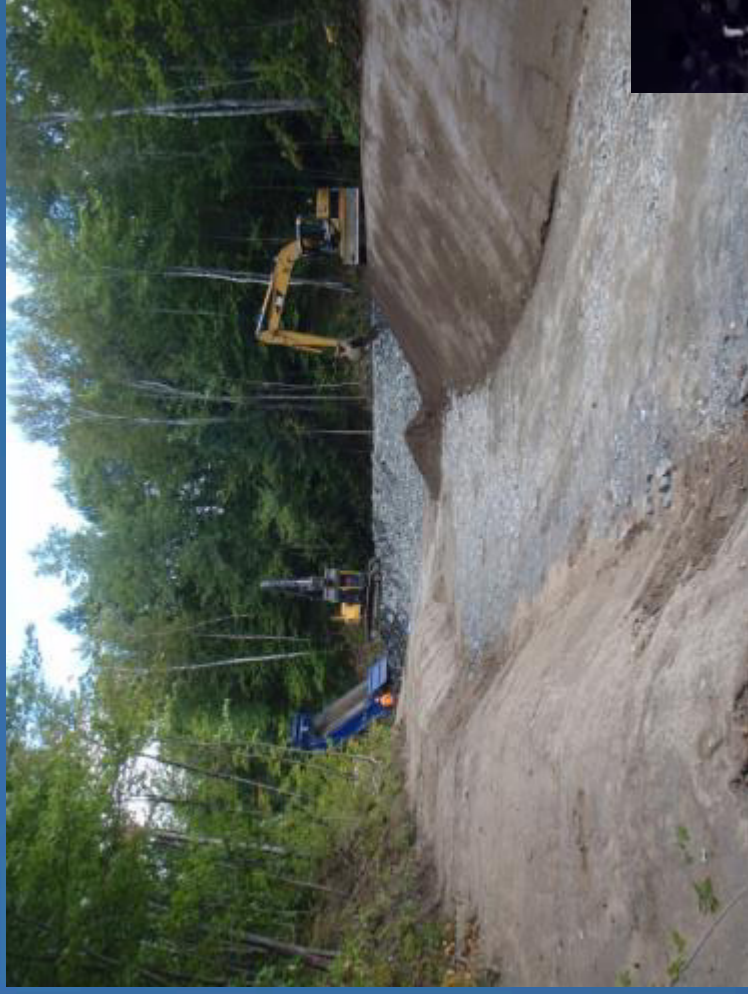
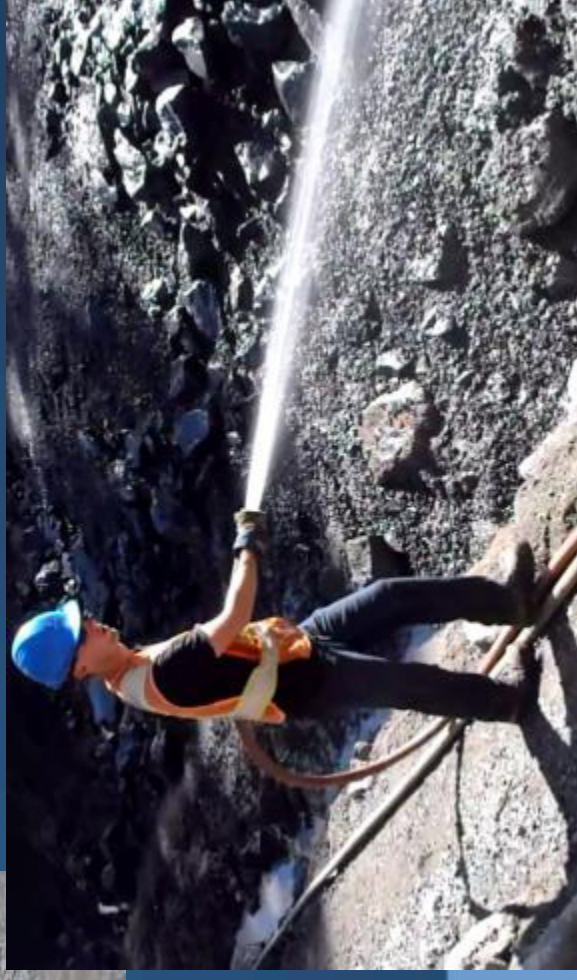
During construction

- Intervention carried out from the base of the slope.
- Heavy machinery uses counterweight as access road.
- To help water flow back on top of riprap as soon as possible, hydraulic pressure is used to clog riprap with finer rock particles.

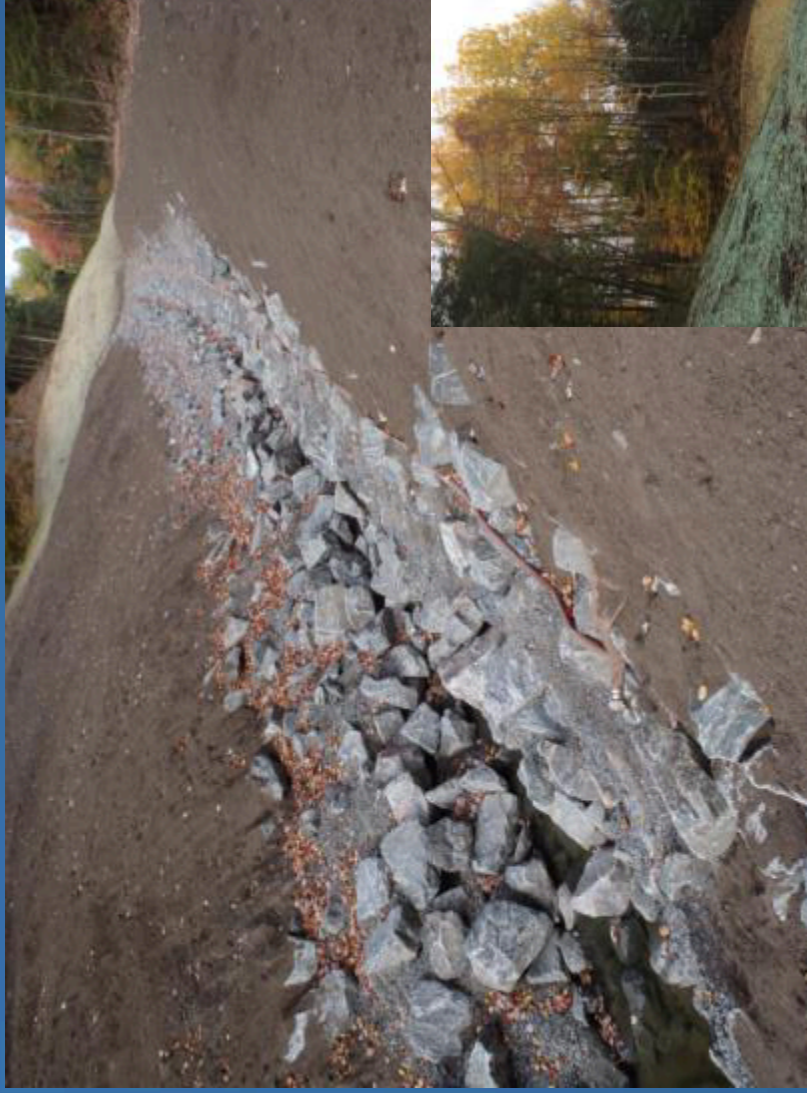
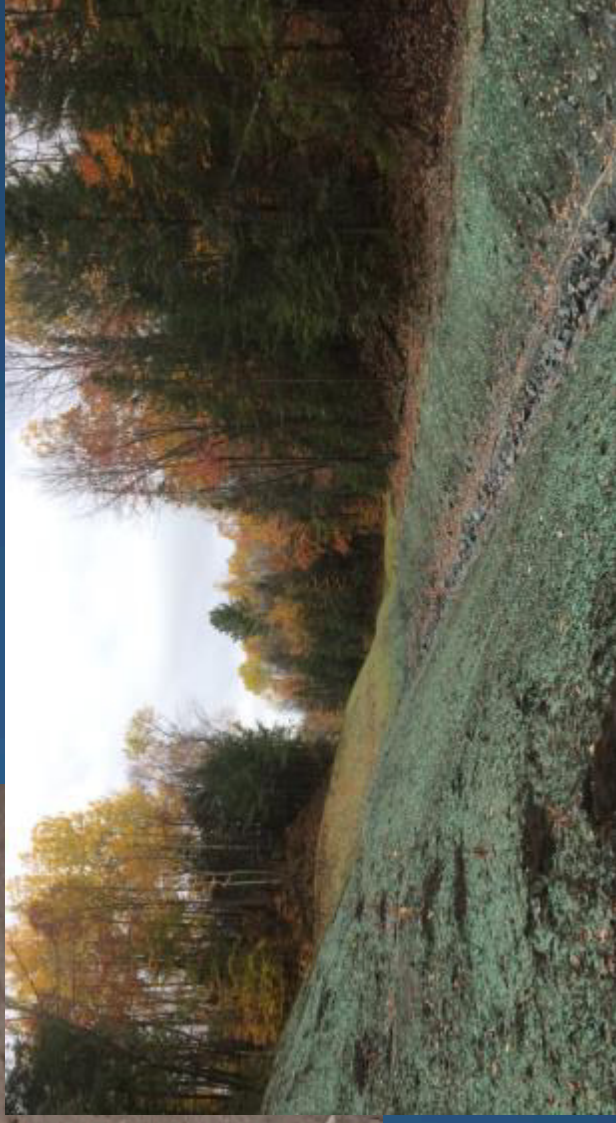
During construction

- Riprap is covered with topsoil.
- Seeding is conducted to provide natural appearance.
